Errata

IWR1642 Device Silicon Errata

Silicon Revisions 1.0 and 2.0

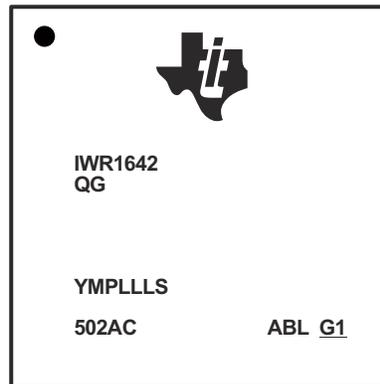
Figure 3-1 shows an example of the IWR1642 Radar Device's package symbolization.

Figure 3-1. Example of Device Part Markings

This identifying number contains the following information:
