# **IWR6243 Device Errata**

## **Silicon Revisions 1.0 and 1.1**

This document describes the known exceptions to the functional and performance specifications to TI CMOS Radar Devices (IWR6243).

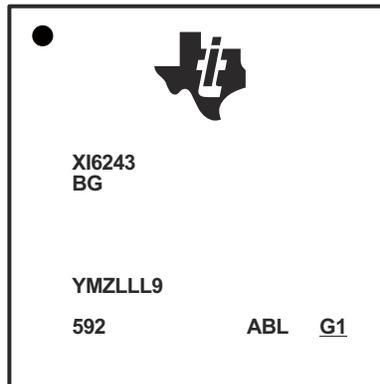
**Figure 3-1. Example of Device Part Markings**

Figure 3-1 shows an example of the IWR6243 Radar Device's package symbolization.

This identifying number contains the following information:
