CC2651R3SIPA SimpleLink™ Wireless MCU Device Revision B

This document describes the known exceptions to functional specifications (advisories) to the CC2651R3SIPA SimpleLink™ device.

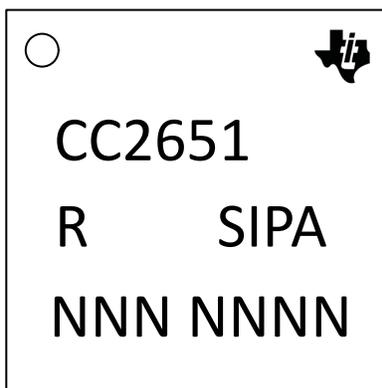
Figure 2-1. Package Symbolization

Figure 2-1 and Table 2-1 describe package symbolization and the device revision code.
