CC2640R2L SimpleLink™ Bluetooth® 5.1 Low Energy Wireless MCU Silicon Revisions F, G

This document describes known exceptions to the functional specifications (advisories) for the CC2640R2L SimpleLink™ Bluetooth® low energy wireless MCU.

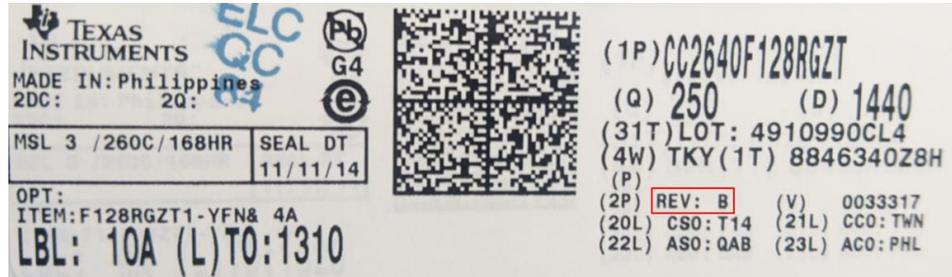
Figure 3. Sample Product Shipping Label for the CC2640 Device

3. Package label:
 - The die revision name is shown on the tape and reel label as shown in the example label in [Figure 3](#).
 - Entry (2P) lists the revision (either F or G).
