Errata

MSPM0H3215, MSPMH03216, MSPR5F100FESNNA, MSPR7F102GBESVFC Microcontrollers

ABSTRACT

This document describes the known exceptions to the functional specifications (advisories).

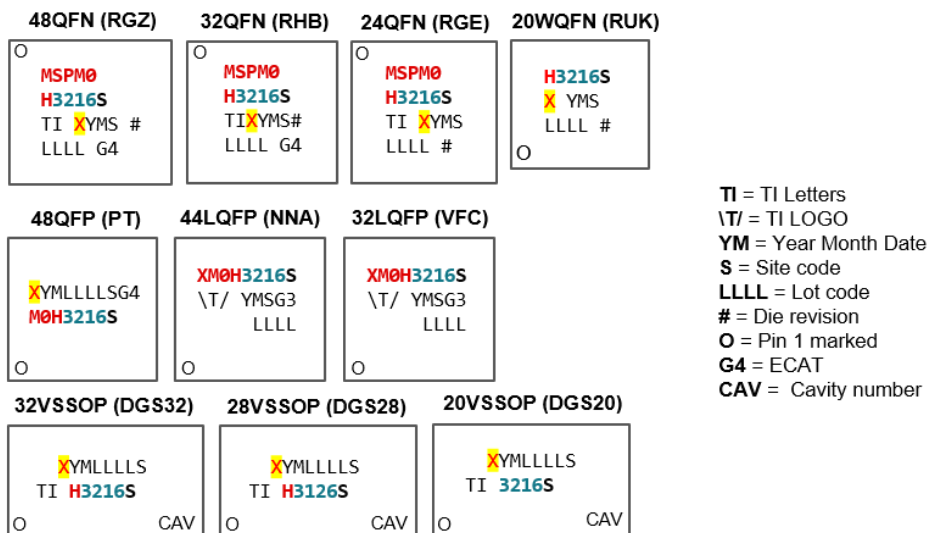
Figure 5-1. Package Symbolization

The package diagrams below indicate the package symbolization scheme, which is the pre-prod version. After release, RTM version will be added here. And [Table 5-1](#) defines the device revision to version ID mapping.
