*TMS570LS20216, TMS570LS20206,
TMS570LS10216, TMS570LS10206,
TMS570LS10116, TMS570LS10106*
Microcontroller
Silicon Revision A

Silicon Errata

TMS570LS Series Microcontroller Silicon Revision A

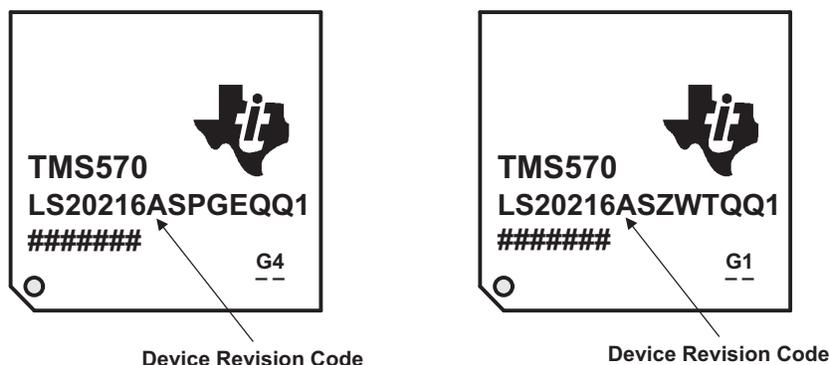
Figure 1 provides an example(s) of the TMS570LS series device markings. The device revision can be determined by the symbols marked on the top of the package.

Figure 1. Example, Device Revision Code for TMS570LS20216 (PGE/ZWT Packages)

Silicon revision is identified by a device revision code. The code is of the format TMS570LS20216x, where "x" denotes the silicon revision. If x is "A" in the device part number, it represents silicon version A.
