**TMS320VC5502 and
TMS320VC5501
Digital Signal Processors
Silicon Errata**

SPRZ020L
December 2002
Revised June 2007

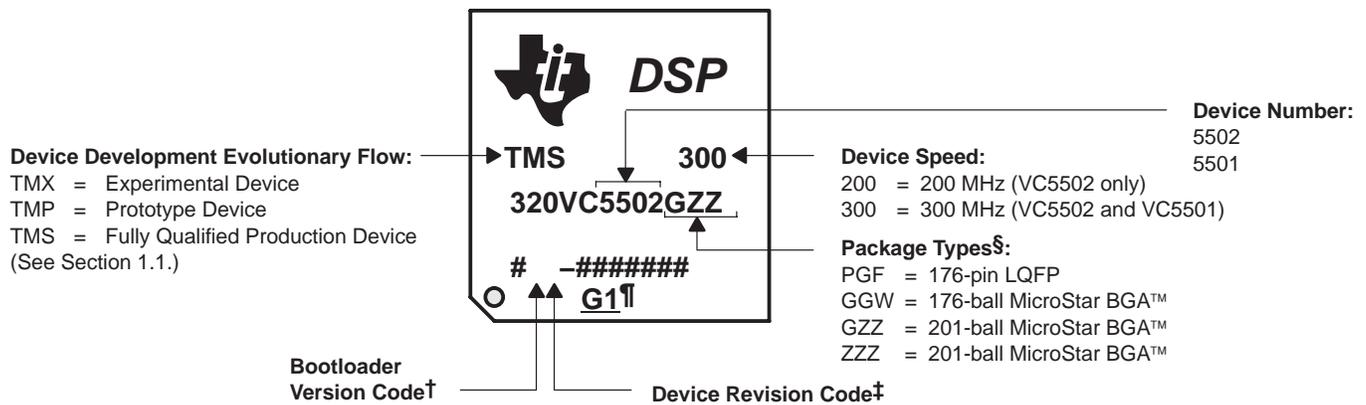
NOTE: “#” denotes alphanumeric character.

† The first space after the first alphanumeric character is reserved for the Bootloader Version Code (see Table 3).

Qualified devices are marked with the letters “TMS”, while nonqualified devices are marked with the letters “TMX” or “TMP”. All GGW package devices are nonqualified devices and are marked with the letters “TMX”.

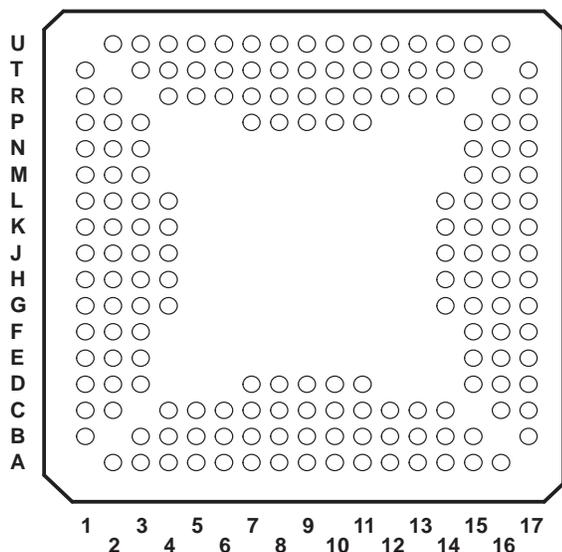
Figure 4. 176-Terminal GGW Package (Bottom View)

The MicroStar BGA option for the TMS320VC5502 and TMS320VC5501 was changed from the 176-terminal GGW package to the 201-terminal GZZ package. The GZZ package is the same as the GGW package with the exception of 25 thermal balls located in a 5x5 array at the center of the package. The 25 thermal balls were included to improve thermal dissipation of the device. Figure 4 and Figure 5 show the GGW package and the GZZ package, respectively.

All mechanical data and thermal resistance information for the GZZ package can be obtained from the device data sheets (see Section 5 for literature numbers). The device data sheets also contain information on how to connect the 25 thermal balls. Information for the GGW package is given below. Please note that the GGW package option will not be supported in the future. Instead, all MicroStar BGA devices for both the 5502 and the 5501 will only be available in the GZZ package. The information here is only presented since some TMX samples were shipped in the GGW package.
