TMS320UC5402/TMS320VC5402
Digital Signal Processors
Silicon Errata

SPRZ155D
November 1999 – Revised April 2003

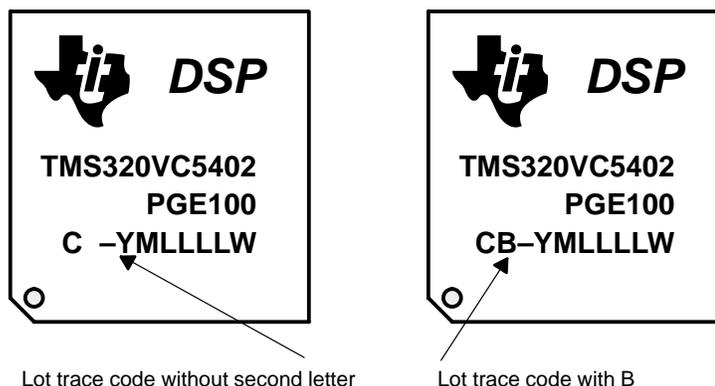
Figure 1. Example, Typical Lot Trace Code for TMS320VC5402 (PGE)

The device revision can be determined by the lot trace code marked on the top of the package. The locations for the lot trace codes for the PGE and the GGU packages are shown in Figure 1 and Figure 2, respectively. The location of other markings may vary per device.

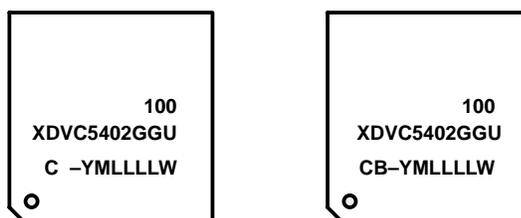
Figure 2. Example, Typical Lot Trace Code for TMS320VC5402 (GGU)
