TMS320C6412
Digital Signal Processor
Silicon Errata

Silicon Revisions 2.0, 1.2, 1.1, 1.0

SPRZ199J
April 2003
Revised February 2010

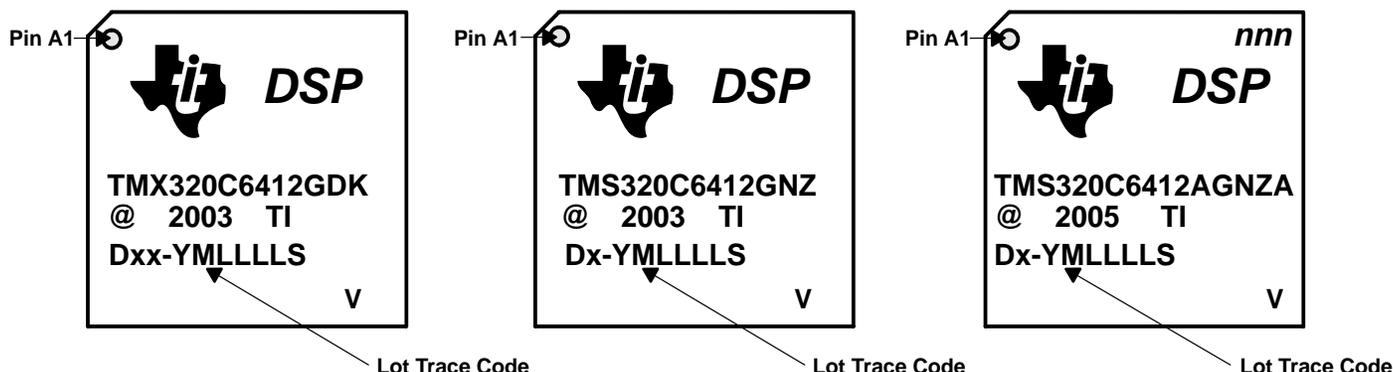
Figure 1. Example, Lot Trace Codes for TMX320C6412 and TMS320C6412 (GDK and GNZ Packages)

The device revision can be determined by the lot trace code marked on the top of the package. The location of the lot trace code for the GDK and GNZ packages are shown in Figure 1. Figure 1 shows **some** examples of the types of C6412 package symbolization for –500 MHz and –600 MHz devices.

NOTE: Pin A1 is always located at the top-left corner when you can read the silkscreening/laser-etching and view the TI logo properly.

“nnn” represents the device speed for the –500 MHz devices **only** (both commercial and extended temperature). For example:

500 = 1.2 V, 500-MHz Core, 100-MHz EMIF

PAGE(S) NO.	ADDITIONS/CHANGES/DELETIONS
5	Added note above Figure 1 detailing position of pin1 when device is properly aligned. Updated Figure 1 to clarify position of pin one. Added description of V at bottom of Figure 1.
