**TMS320DM643**  
**Digital Signal Processor**  
**Silicon Errata**

**Silicon Revision 2.0, 1.2**

*SPRZ231A*  
March 2005  
Revised August 2005

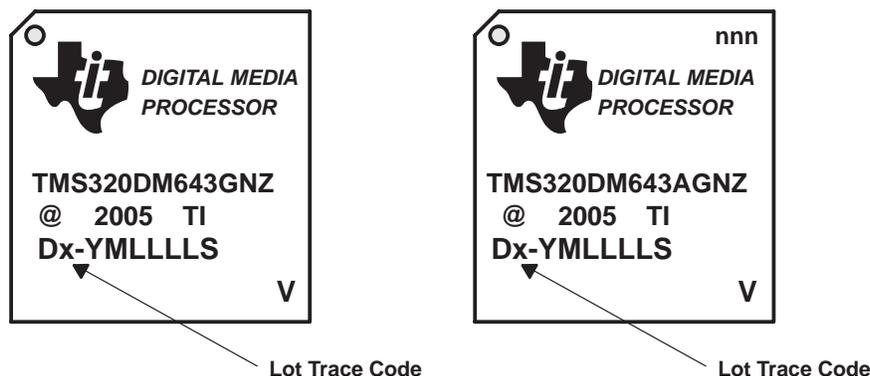
**Figure 1. Example, Lot Trace Codes for TMS320DM643 (GDK and GNZ Packages)**

The device revision can be determined by the lot trace code marked on the top of the package. The location of the lot trace code for the GDK and GNZ packages are shown in Figure 1. Figure 1 shows **some** examples of the types of DM643 package symbolization for –500 MHz and –600 MHz devices.

“nnn” represents the device speed for the –500 MHz device **only**.  
 For example:  
 500 = 1.2 V, 500-MHz Core, 100-MHz EMIF

NOTE: Qualified devices are marked with the letters “TMS” at the beginning of the device name, while nonqualified devices are marked with the letters “TMX” or “TMP” at the beginning of the device name.
