# **AWR6443 Device Silicon Errata**

## **Silicon Revision 2.0**

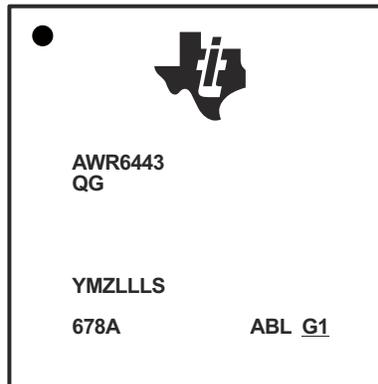
**Figure 3-1. Example of Device Part Markings**

Figure 3-1 shows an example of the AWR6443 Radar Device's package symbolization.

This identifying number contains the following information:
