Errata

IWRL6432AOP Device Silicon Errata

This document describes the known exceptions to the functional and performance specifications to TI CMOS Radar Devices (IWR6432AOP)

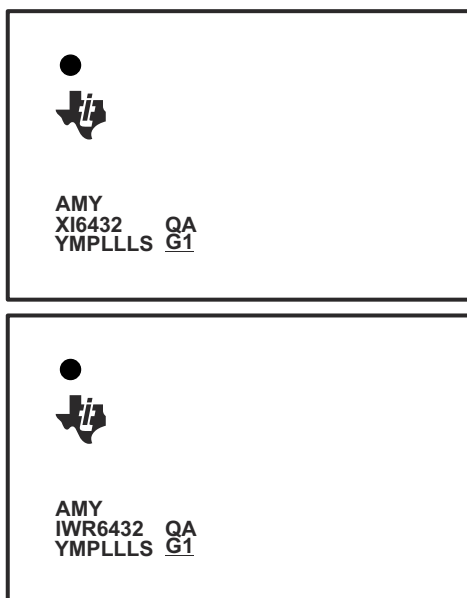
Figure 3-1. Example of Device Part Markings

Figure 3-1 shows an example of the IWR6432AOP Radar Device's package symbolization.
