Errata

**AWR2944P, AWR2E44P, AWR2944-ECO, AWR2E44-ECO,  
AWR2944LC, AWR2E44LC Device Errata**

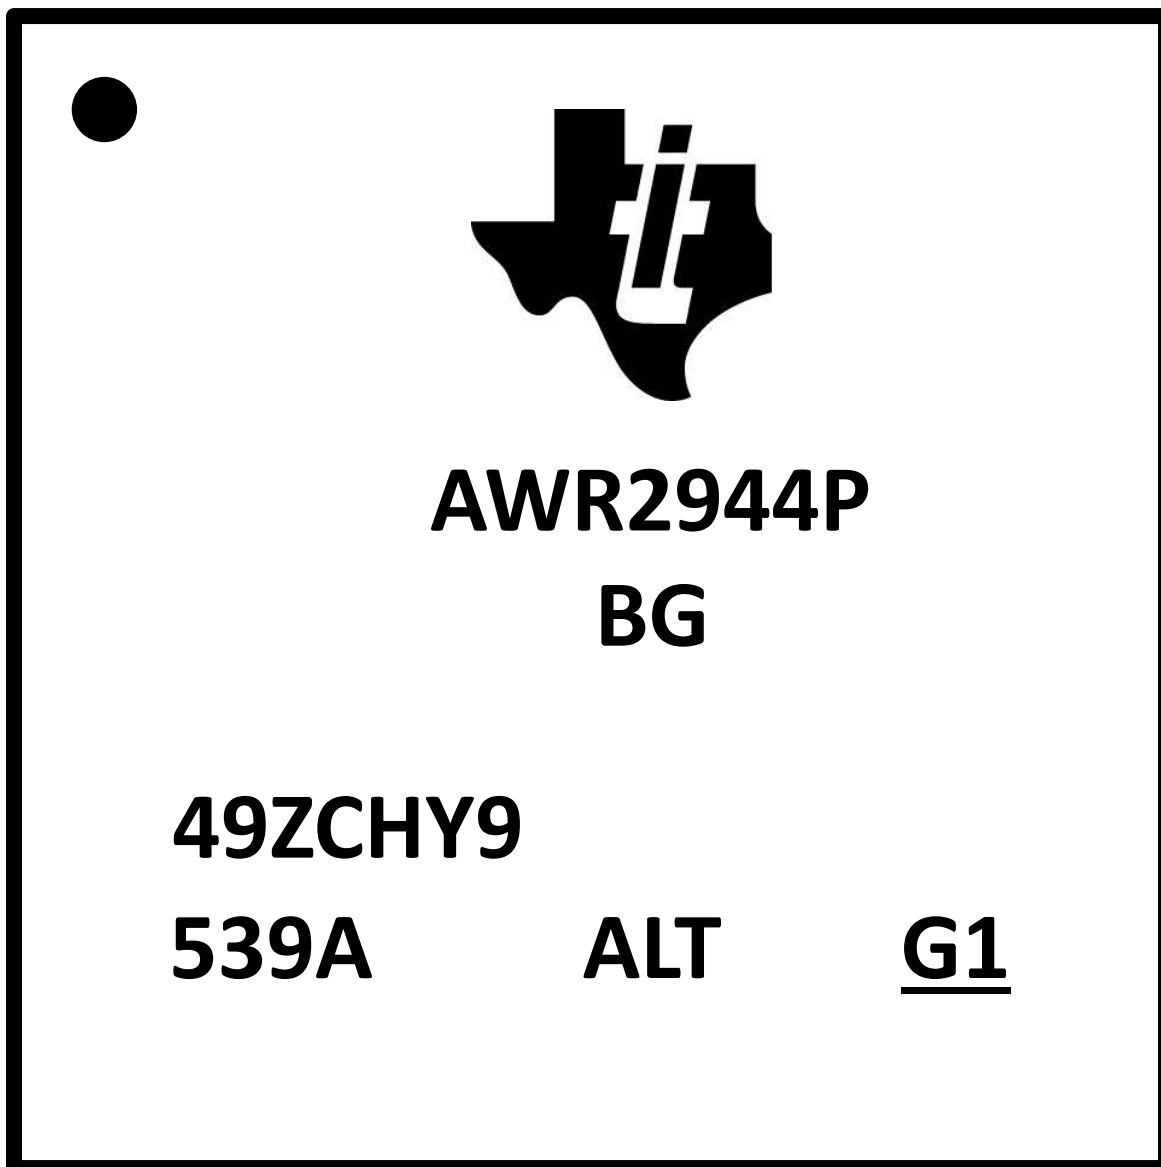
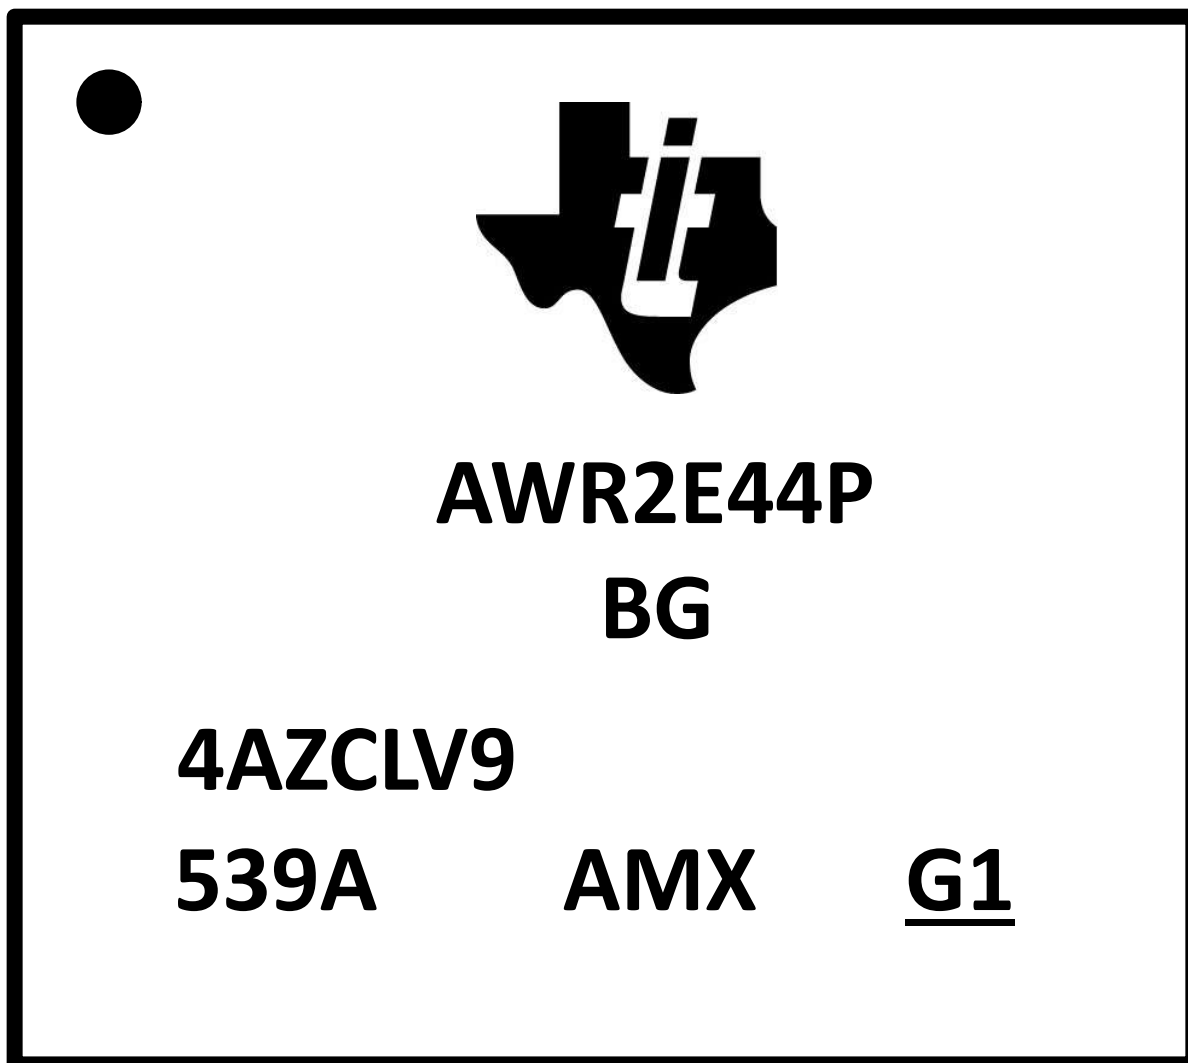
**Figure 3-1. Example of Device Part Markings**

Figure 3-1 shows an example of the AWR2944P/AWR2E44P Radar Device's package symbolization. AWR2944-ECO, AWR2E44-ECO, AWR2944LC, AWR2E44LC will have similar markings with 'E' and 'L' respectively in place of 'P' on line 1.

This identifying number contains the following information:
