# Application Note

## DP83867 Troubleshooting Guide

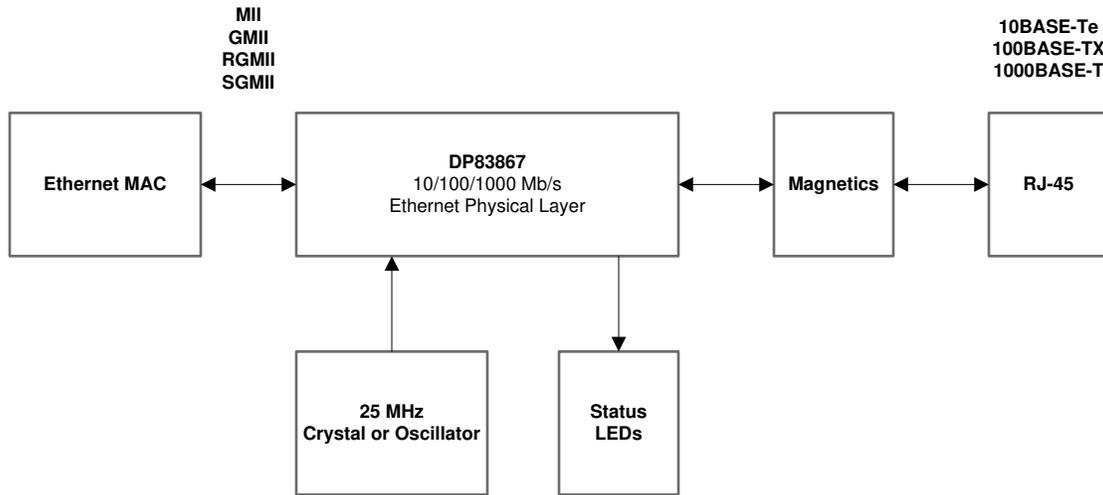
**Figure 1-1. DP83867 Block Diagram**

Figure 1-1 is a high-level system block diagram of a typical DP83867 application.

The DP83867 can connect to an Ethernet MAC and to a media. The connection to the media is via a transformer and a connector.

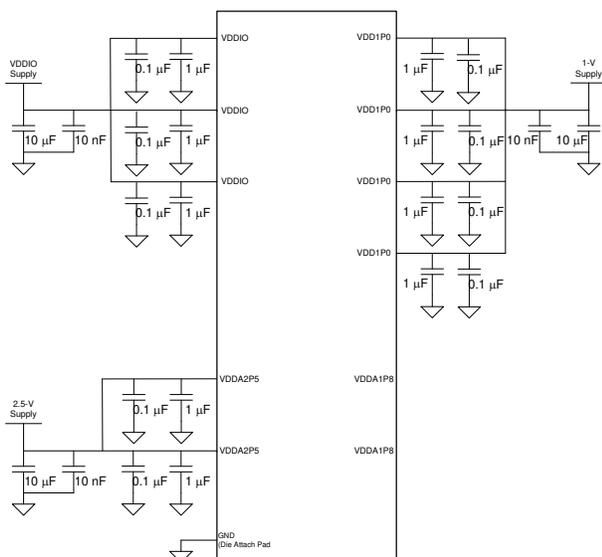
**Figure 2-1. Two Supply Configuration**

The DP83867 supports two configurations for power supplies as shown in [Figure 2-1](#) and [Figure 2-2](#). DP83867 can operate with as few as two supplies. When operating in the three-supply configuration, the VDDA1P8 supply

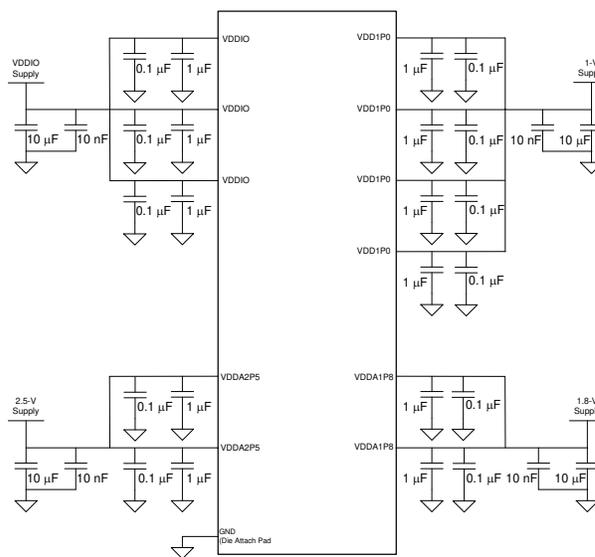
**Figure 2-2. Three Supply Configuration**

must be stable within 25ms of the VDDA2P5 supply ramping up. There is no sequencing requirement for other supplies when operating in three supply mode. When powering down the DP83867, the VDDA1P8 supply needs to be brought down before the VDDA2P5 supply. Power up the board and verify the sequence of these supplies with an oscilloscope.

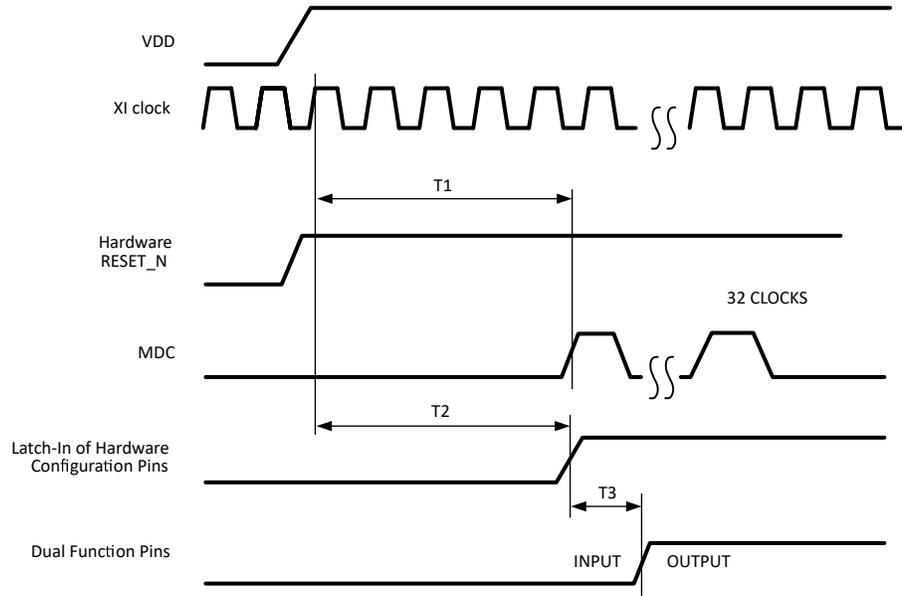
**Figure 2-3. Strap Latch-in Process**

Strap Latch-in process occurs during power up process. Latch-in event normally occurs within 200ms after VDD pull up.

PARAMETER	TEST CONDITIONS <sup>(1)</sup>	MIN	NOM	MAX	UNIT
T1	Post power-up stabilization time prior to MDC preamble for register accesses		200		ms
T2	Hardware configuration latch-in time from power up		200		ms
T3	Hardware configuration pins transition to output drivers		64		ns

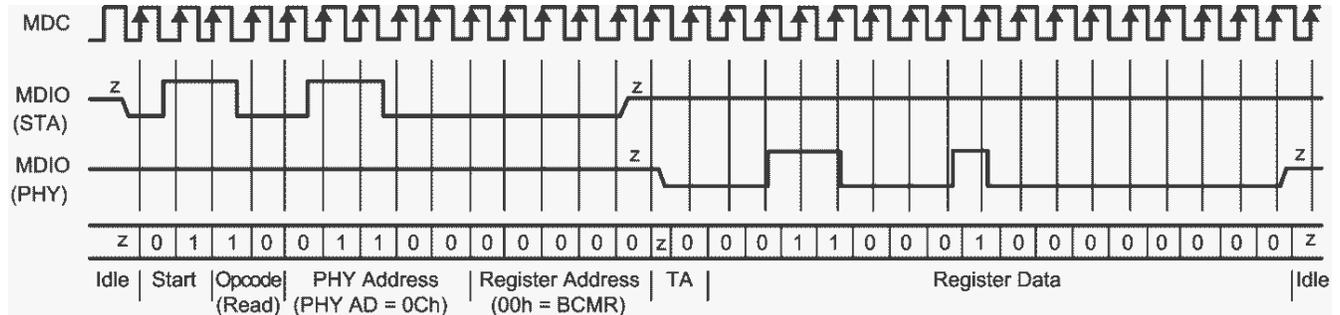
**Figure 2-4. Typical MDC/MDIO Read Operation**

1. MDIO should pull up to the I/O supply when undriven. Probe MDIO to confirm the default voltage.
2. Confirm processor and PHY have the same VDDIO voltage.
3. MDC should not have any pull up or pull down resistor.
4. Attempt to read the registers. Probe the MDC/MDIO signals during read and write operations, referencing the expected waveforms in the following images.

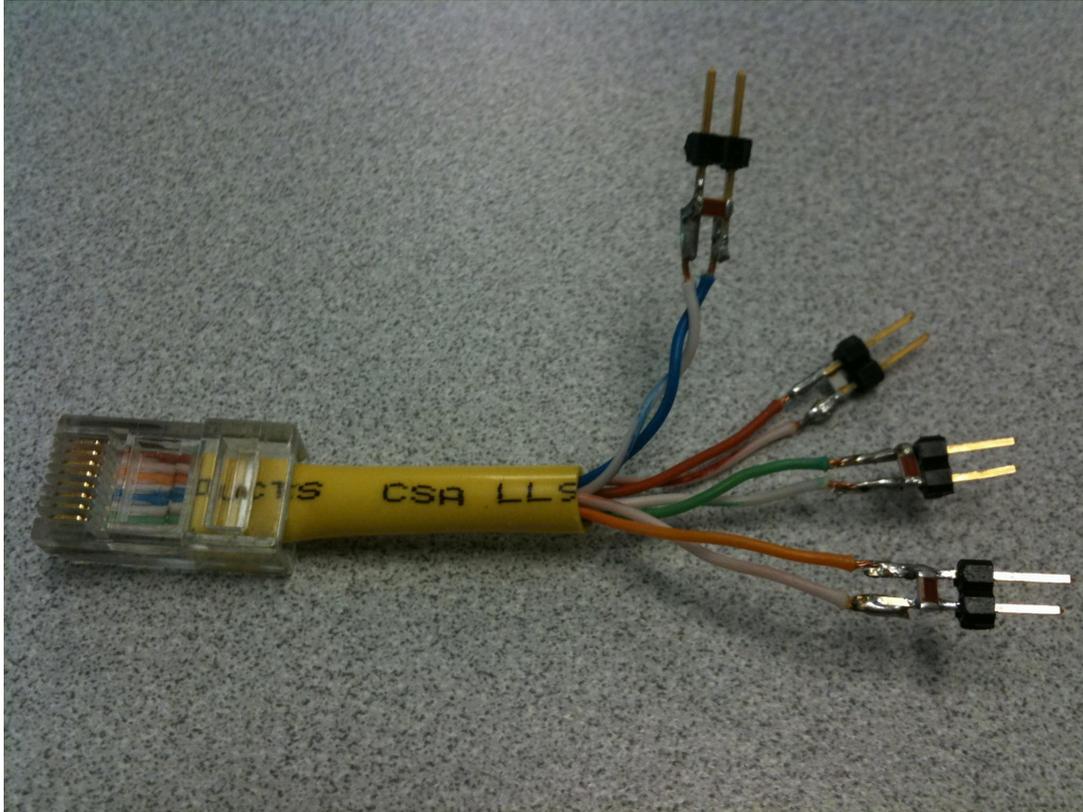
**Figure 2-6. 100 Ohm Terminated Cable for MDI Signal Measurement**

A short Ethernet cable with 100 Ohm terminations can be used for measuring the MDI signals. A terminated cable is shown in [Figure 2-6](#). A connection diagram for making measurements with the terminated cable is shown in [Figure 2-7](#).

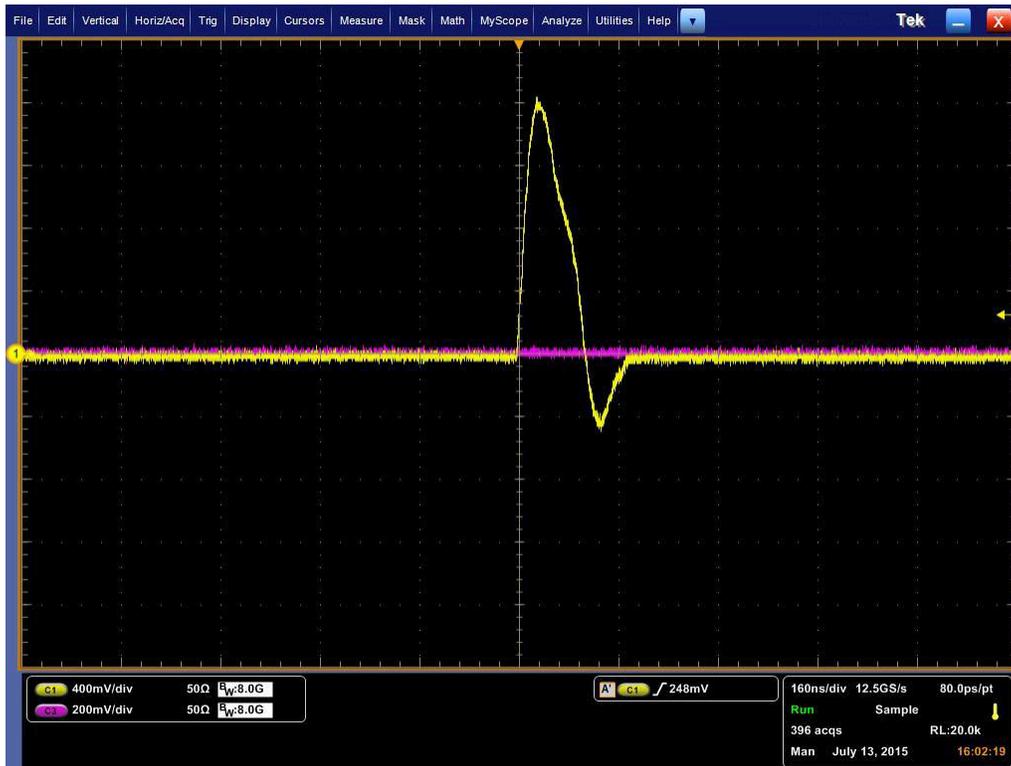
**Figure 2-8. DP83867 Link Pulse**

Auto-Negotiation link pulses are nominally 100ns wide. Pulses are spaced by 62µs or 125µs and are transmitted in bursts. The bursts are nominally 2ms in duration and occur every 16ms. An example link pulse is shown below in Figure 2-8.

Observing this pulse confirms the PHY is on and attempting to link.

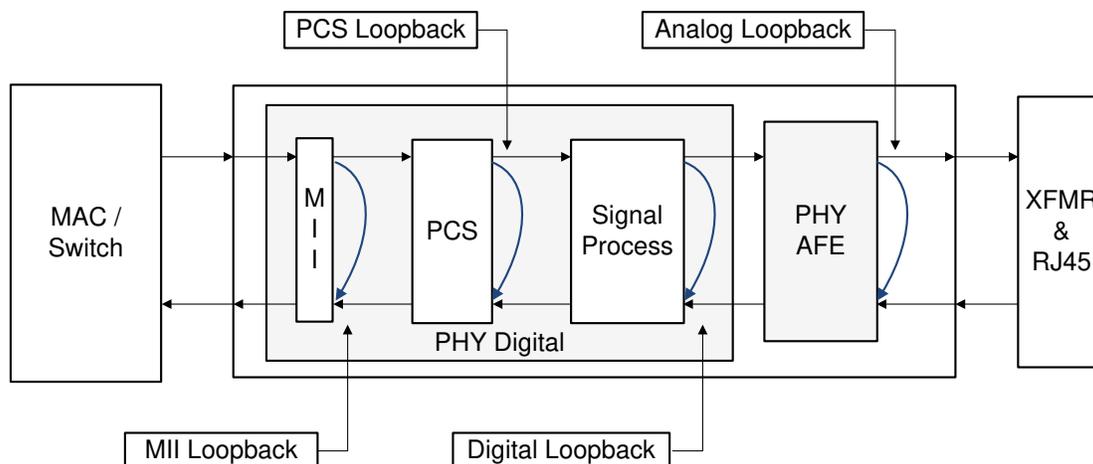
**Figure 2-9. Block Diagram, Loopback Modes**

Loopback mode could determine the communication issue occur on MAC < -- > PHY or PHY < -- > PHY. MII loopback, PCS loopback, Digital Loopback, and Analog Loopback could isolate the PHY < -- > PHY communication. Reverse Loopback could isolate the MAC < -- > PHY communication. The following diagrams illustrate the various loopback mode that DP83867 have:

Analog loopback is typically used to verify the PHY's full internal data path, while reverse loopback is used with a link partner to verify the data path along the MDI.

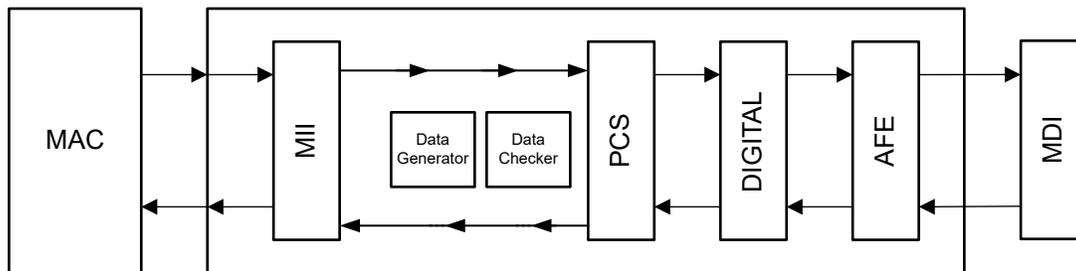
This device incorporates an internal PRBS Built-in Self Test (BIST) circuit to accommodate in-circuit testing or diagnostics. The BIST circuit can be used to test the integrity of the transmit and receive data paths. BIST can be performed using various loopback modes to isolate any issues to specific parts of the data path. The BIST generates packetized data with variable content and IPG.

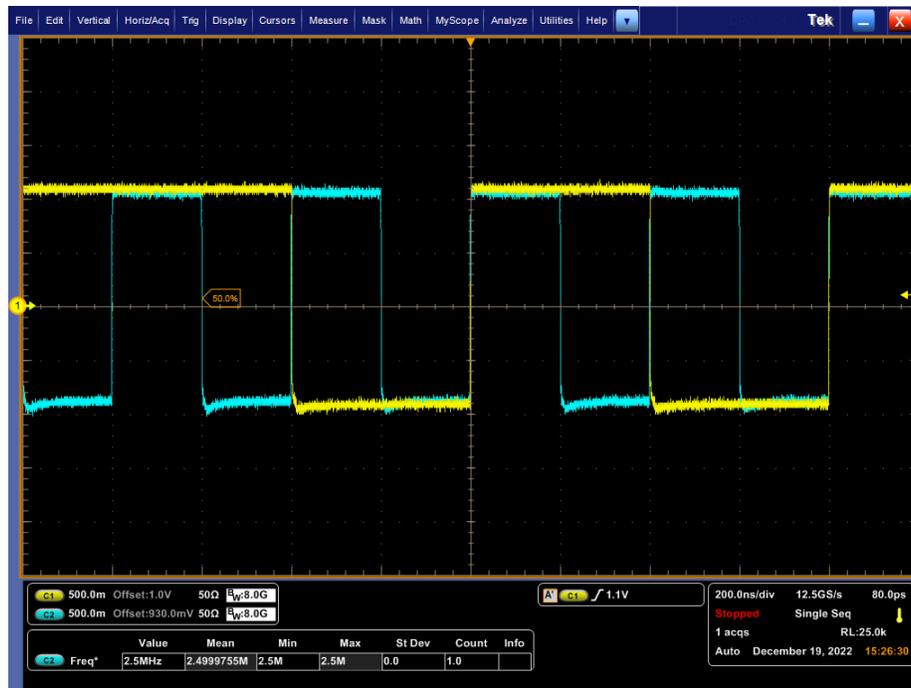
**Figure 2-11. 10 Mbps Data Aligned with RX\_CLK**

Verify the frequency of the clock (C2) as 2.5MHz, and the data (C1) being sampled at the rising edge of the clock.

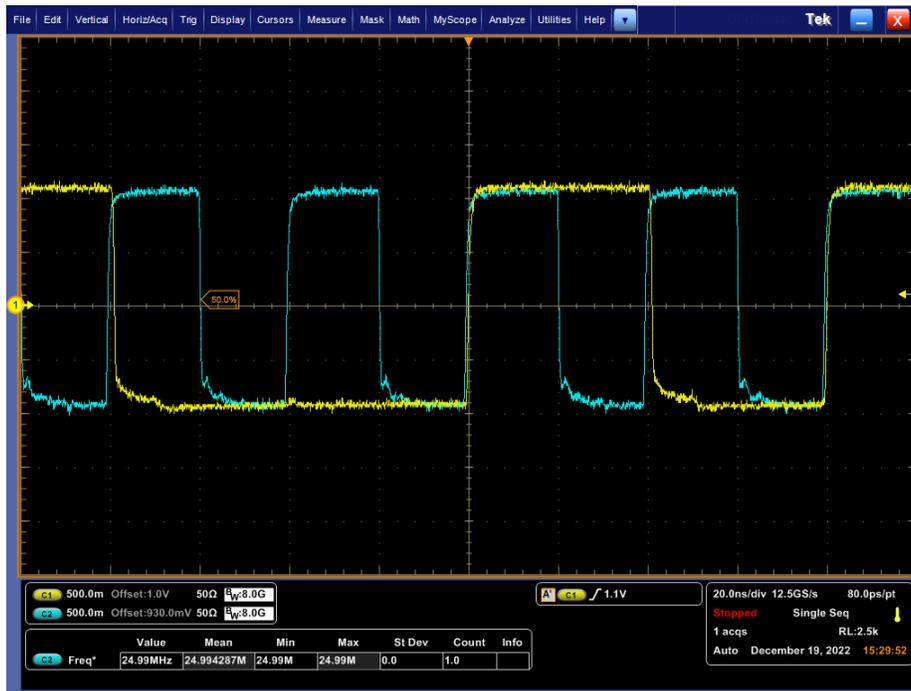
**Figure 2-12. 100 Mbps Data Aligned with RX\_CLK**

Verify the frequency of the clock (C2) as 25MHz, and the data (C1) being sampled at the rising edge of the clock.

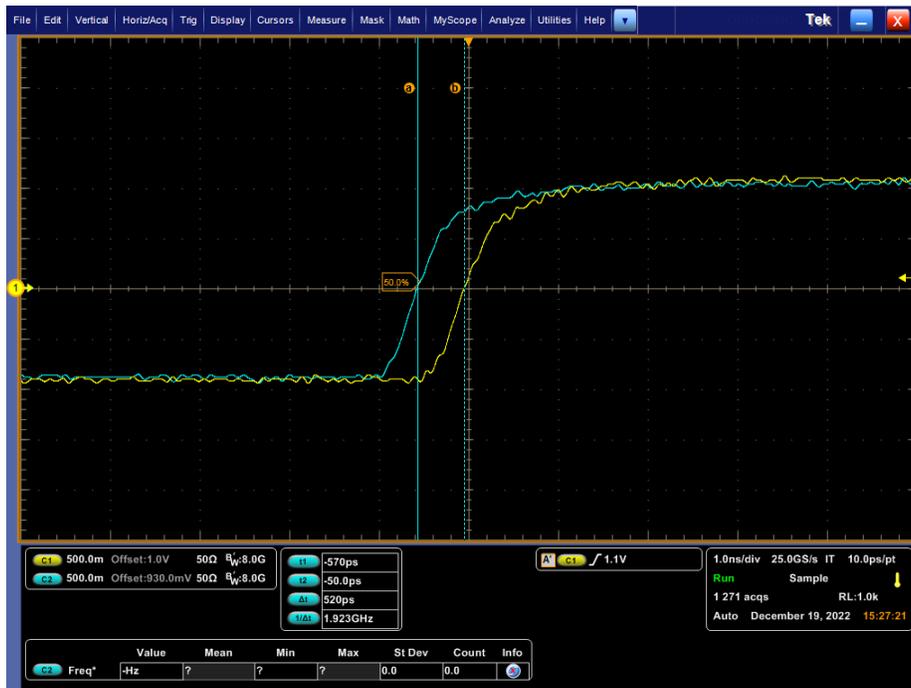
**Figure 2-13. 10Mbps Data and Clock Delay in Align Mode**

Verify the delay between clock and data is <500ps in align mode.

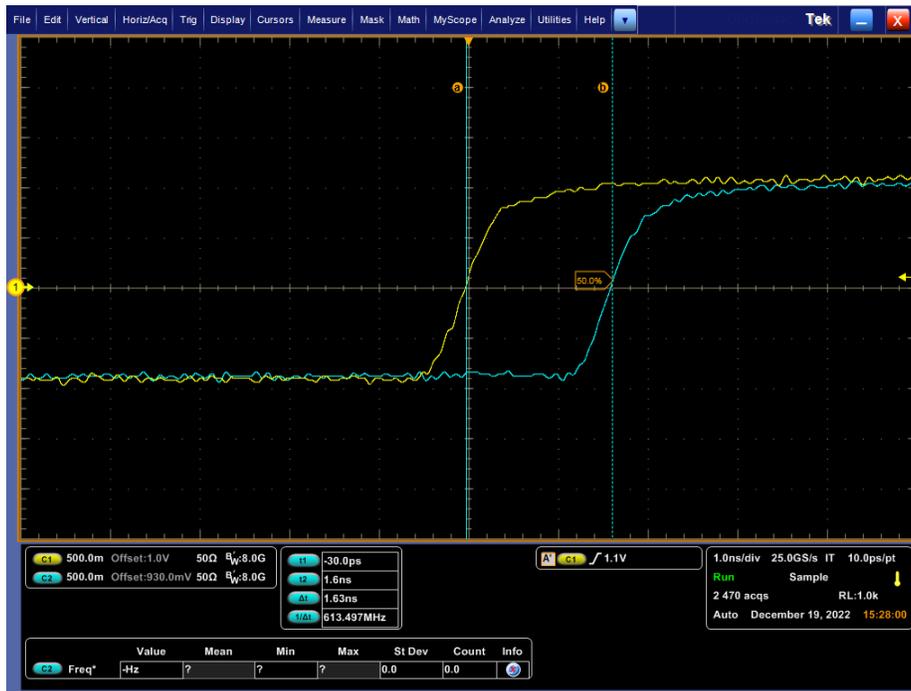
**Figure 2-14. 10 Mbps Data and RX\_CLK in Shift Mode (4ns Programmed Delay)**

Verify the delay between clock and data is >1ns in shift mode. The programmed delay is relative to the clock's initial position in aligned mode. Measuring the difference in the clock's position before and after setting shift mode yields a value closer to the programmed delay.

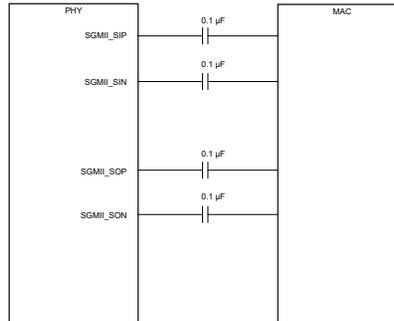
1. Check register 0x0037 bit[1:0] for link up status of SGMII interface.
2. Check schematic on SGMII lines make sure there is 0.1uF DC blocking caps.

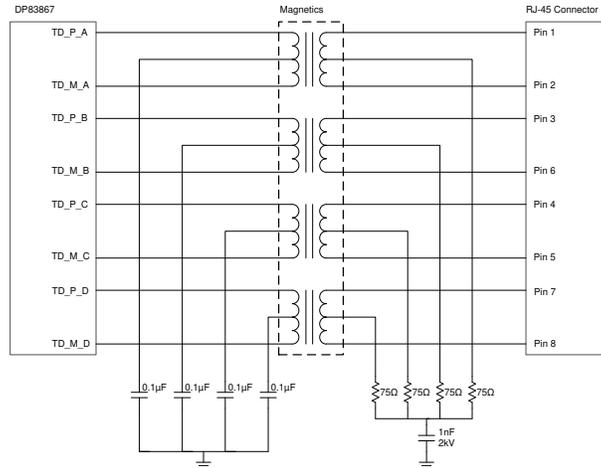
- Check the schematic
  - Make sure the Transformer follow data sheet specification in [Section 2.3.1](#).
  - No shorted center taps on transformer
  - Double check on the capacitors on the center taps of transformer

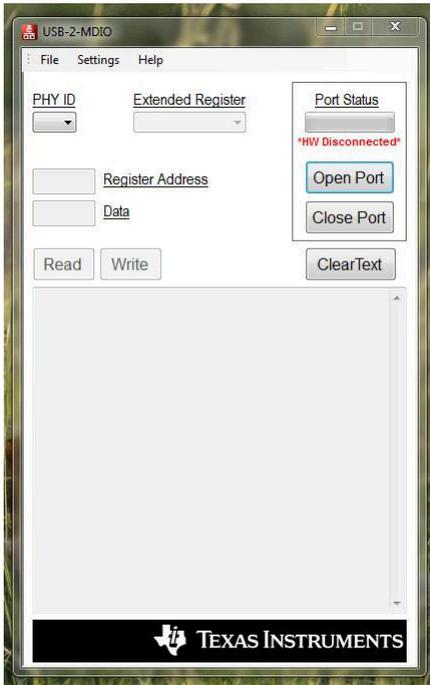
**Figure 3-1. USB-2-MDIO GUI**

If register access is not readily available in the application, USB-2-MDIO GUI is available from TI and can be used with an MSP430 Launchpad, and purchased through [TI.com](http://TI.com). The GUI supports reading and writing registers as well as running script files. USB-2-MDIO GUI can be used with the DP83867 and the other devices in TI's Ethernet portfolio. The USB-2-MDIO User's Guide and GUI are available for download at: [USB-2-MDIO serial management tool](#).
